## **NTSB Weather Related Accidents**

Donald Eick – NTSB Senior Meteorologist Friends and Partners in Aviation Weather

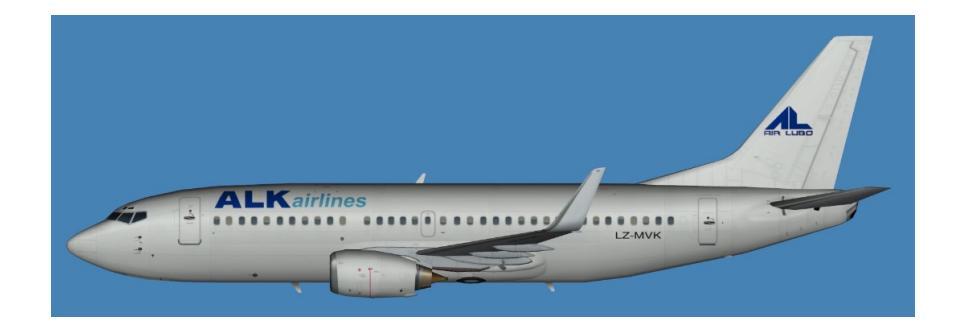
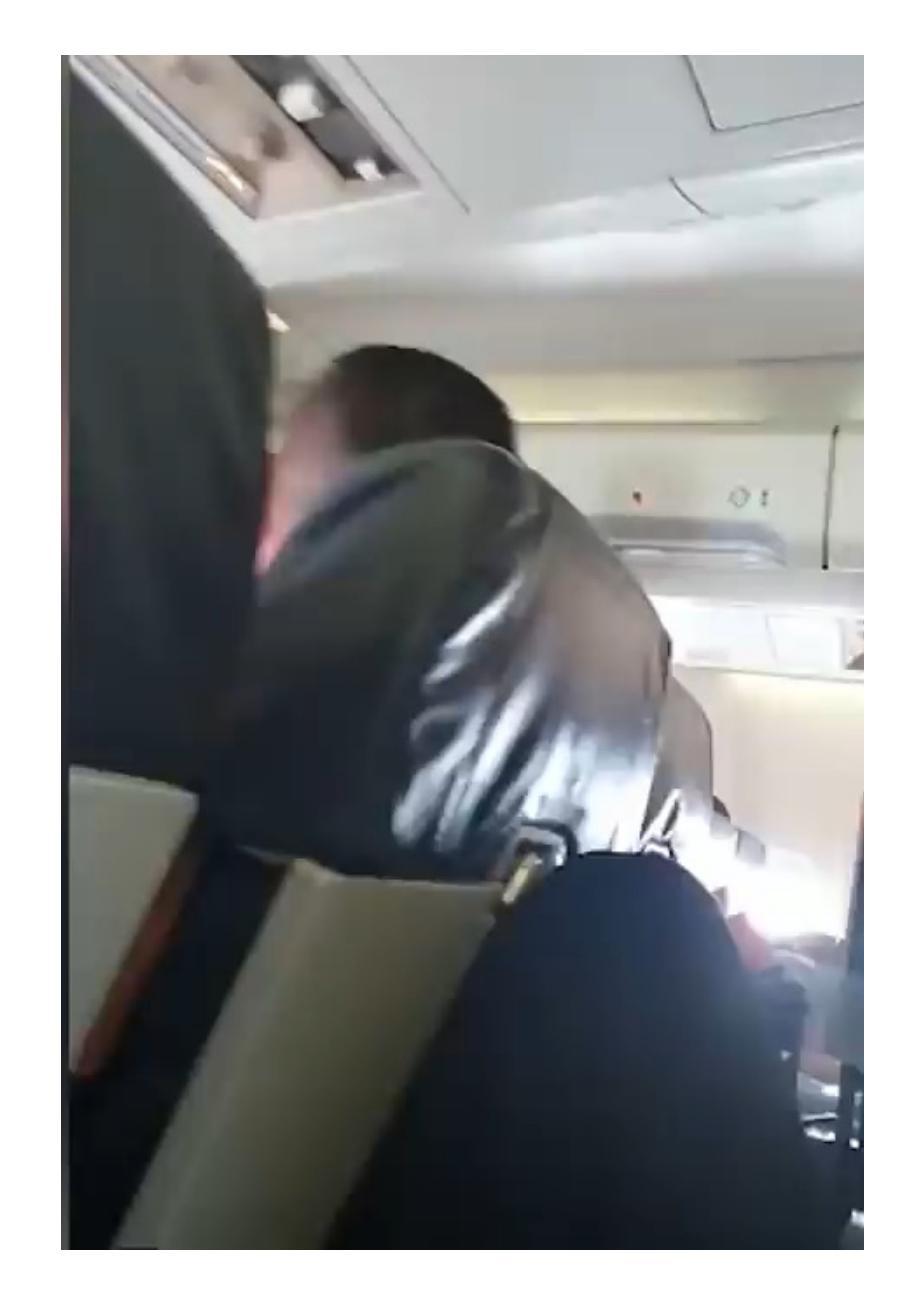
#### **Severe Turbulence Encounter**

ALK Airlines B737-300 from Kosovo to Switzerland on June 16, 2019 enroute at FL340 while deviating around thunderstorms encountered severe turbulence causing injury to 10.

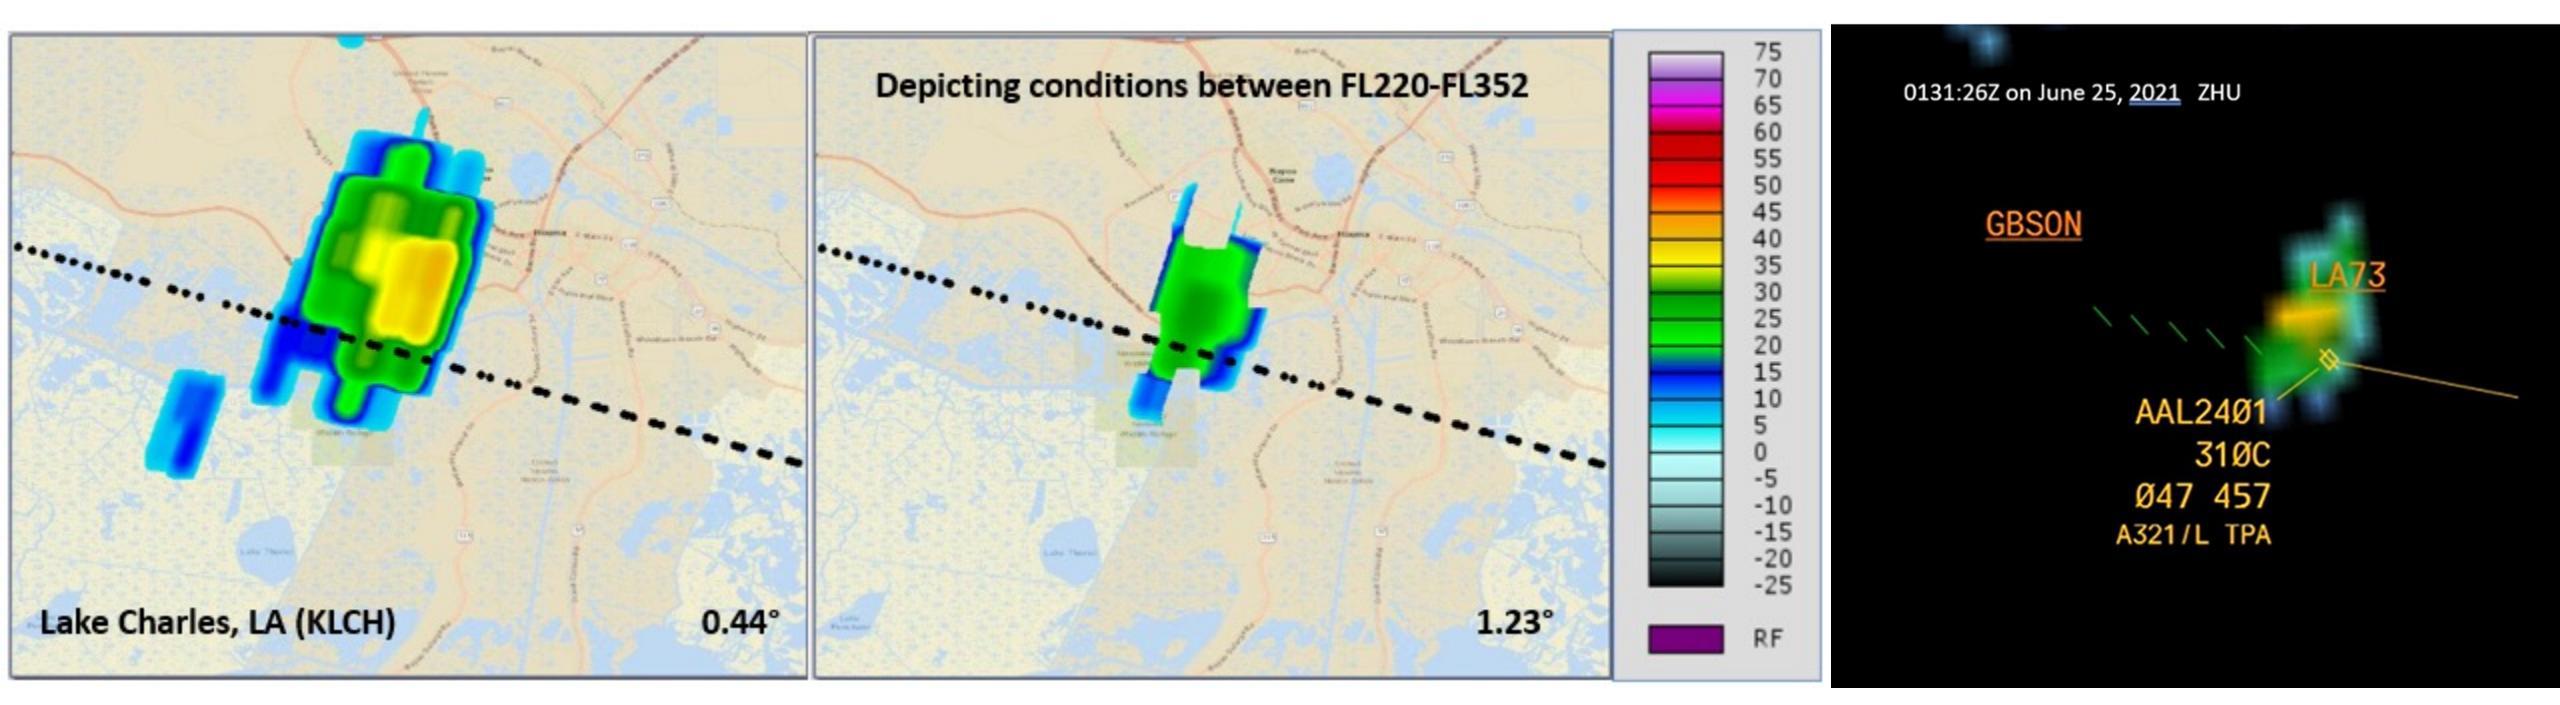
#### DCA21LA164 - New Orleans, LA

- Review of the closest NWS WSR-88D depicted a rapidly developing area of echoes of 45-50 dBZ develop under the flight path with echoes of 30 dBZ reaching the flight level.
- Flight had WX radar turned off at the time, before entering cloud
- ATC did not provide weather advisories (layer CREF High on left)

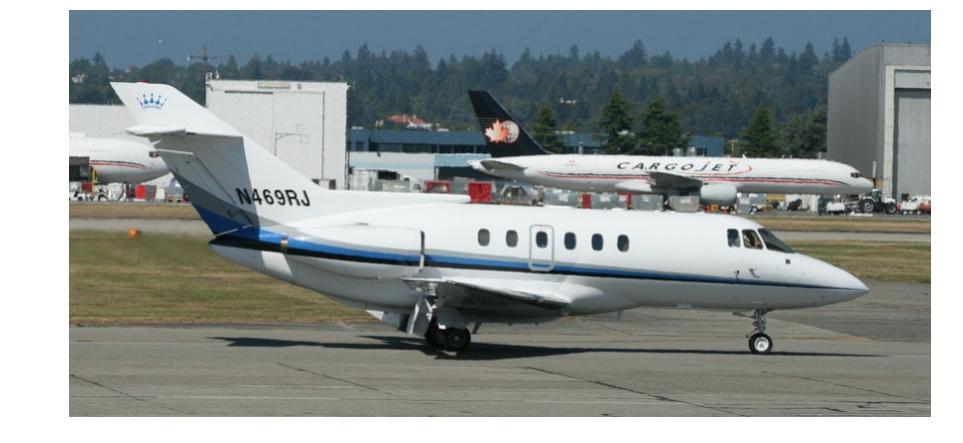
CEN20LA028 – Detroit, MI BAE 125-800A, N469RJ December 3, 2019 @ 0833 EST (1333Z)

- Part 135 repositioning flight
- From: Willow Run (YIP) to Detroit (DET), MI (~25nm)
- Pilots: both ATR with excess of 16,000 hr
- Obtained local conditions, no official briefing & filed IFR flight plan.
- METAR KDET 031253Z 26008KT 10SM OVC011 M01/M03 A2987 RMK A02 T10111028=
- ILS approach RWY 33; used standard Vref 138kt for their weight
- On descent picked up icing in clouds, turned on TKS system, broke out of clouds at 1,000 ft. Over runway in flare the right wing "dropped" and stalled, hitting hard on right wing.
- Pilot indicated no stick shaker; while non-flying pilot felt it after the event. CVR confirmed pilot's statements.
- Aircraft substantial damage; pilots unhurt.

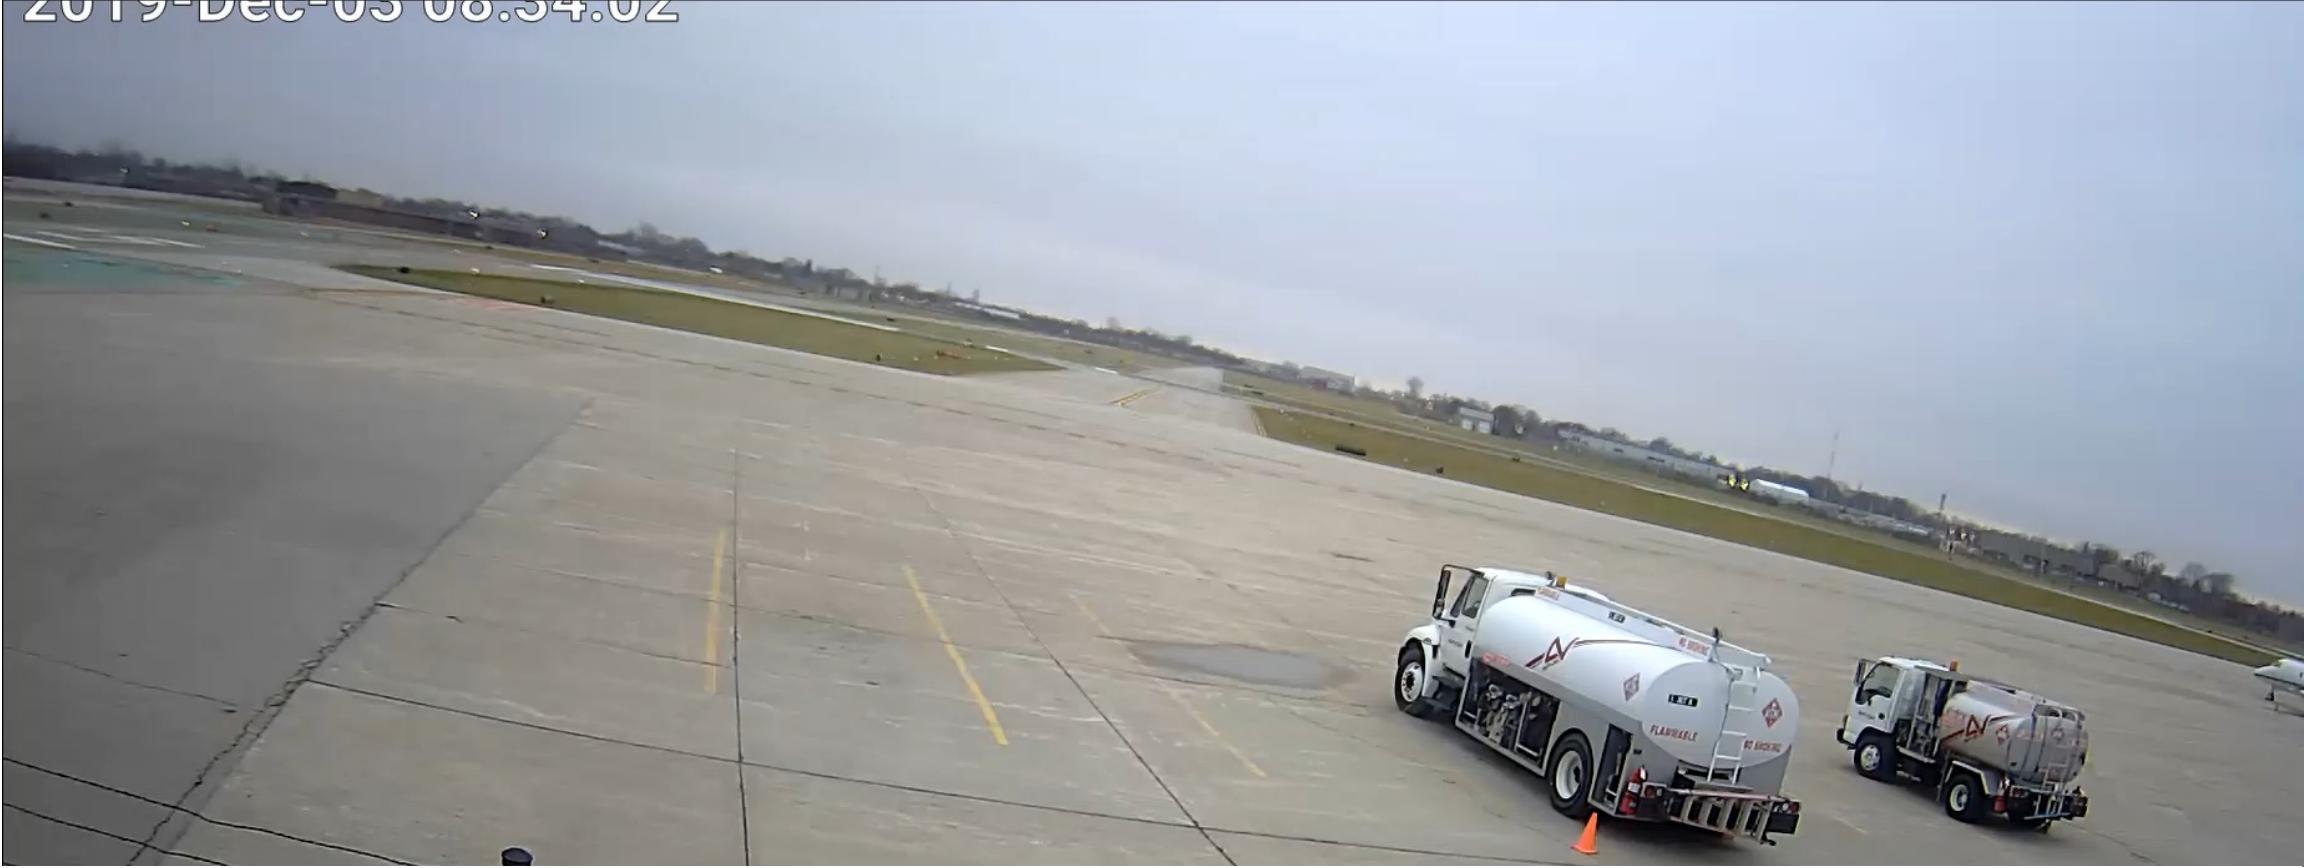
Pilot of Hawker, N122LJ, which landed at 0810 EDT, indicated that they also encountered light icing on approach between 3,000 ft to 1,000 ft. Prior to entering the clouds, they had turned on their TKS, engine heat, and engine ignition. Upon exiting the aircraft, they observed visual signs of ice buildup on the leading edges of the wing, tail surfaces, and the temperature probe which had an umbrella shape ice formation. While both outer ends of the horizontal stabilizer had a "T" shape 9" ice formation on both surfaces.

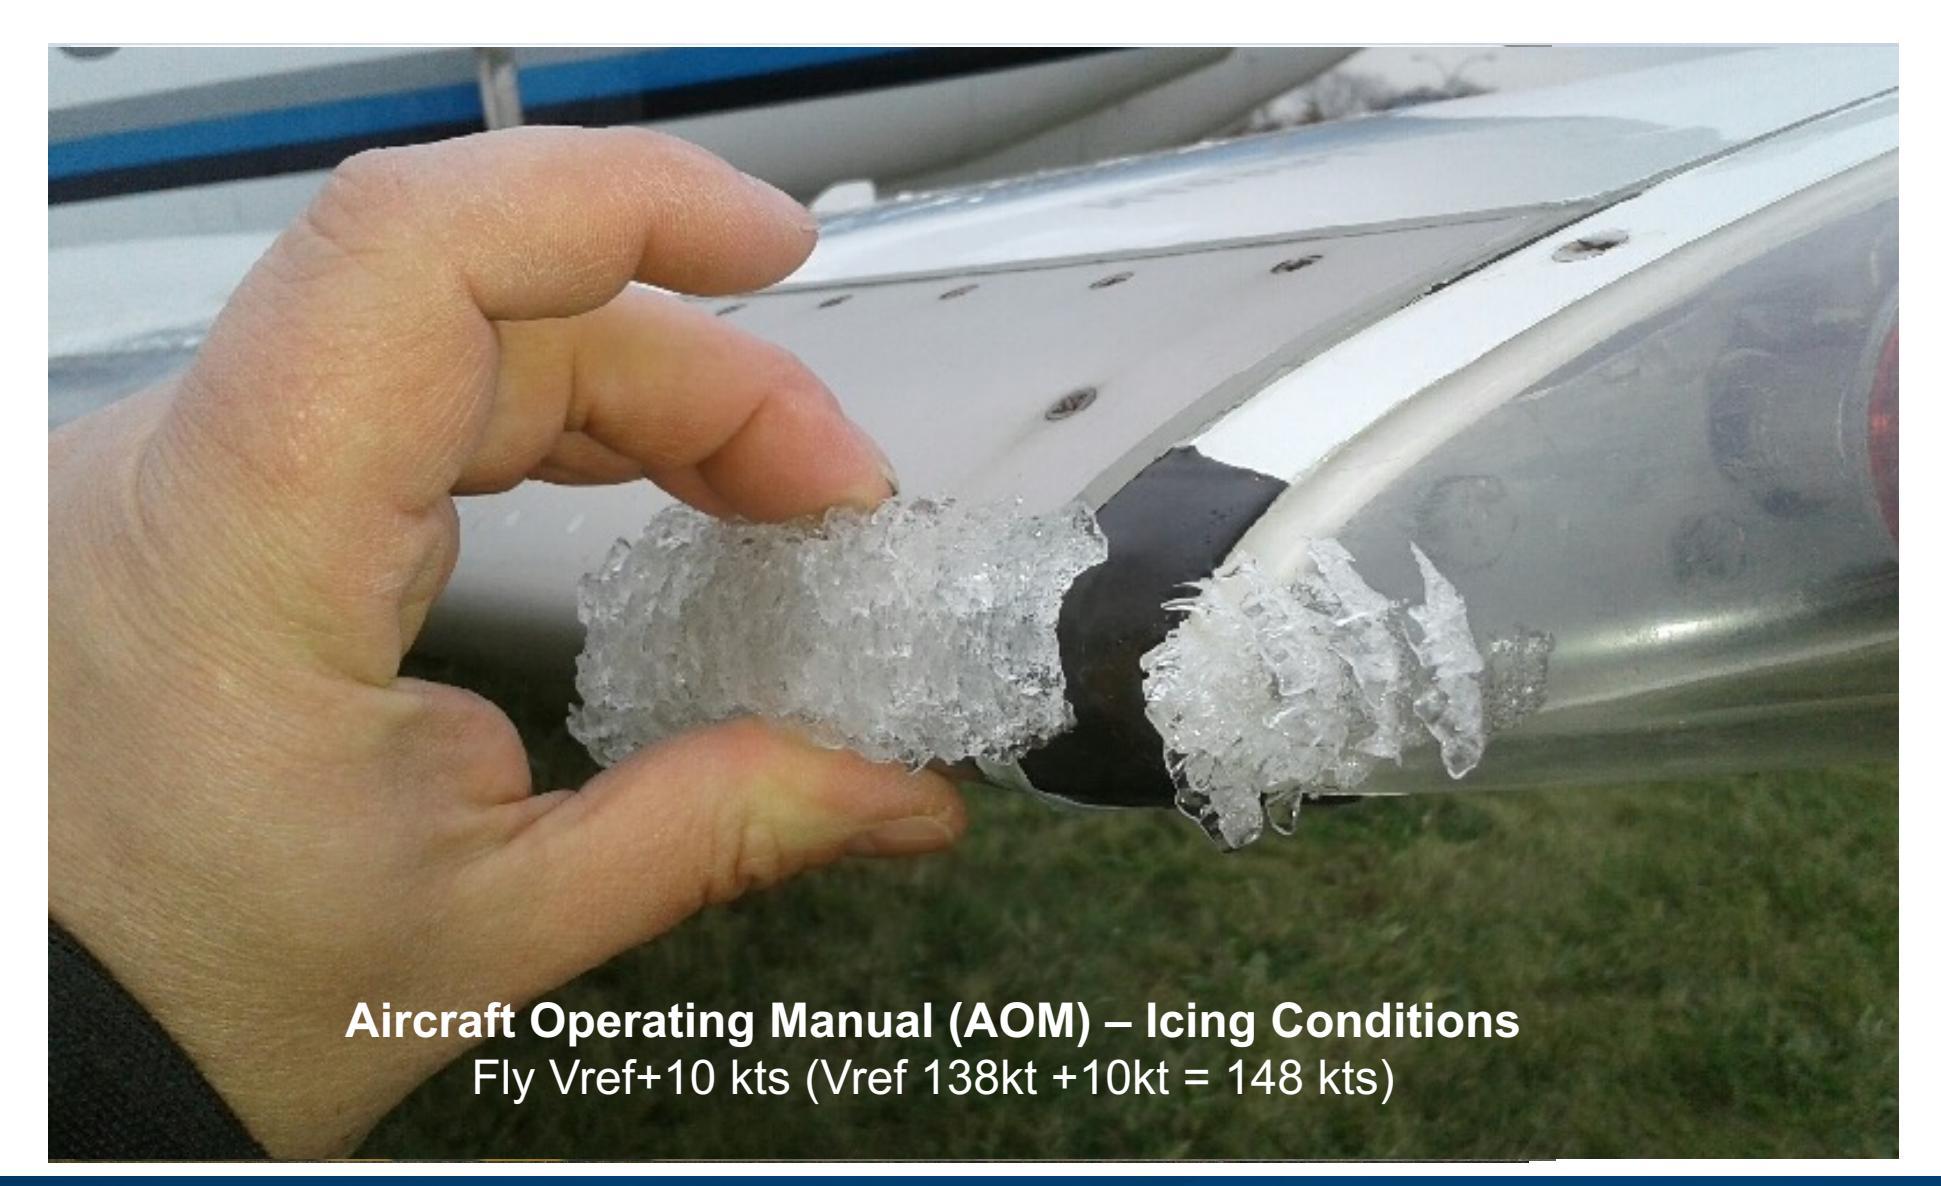
#### CEN20LA028 – Detroit, MI

The pilots' failure to increase approach speed as recommended for flight in icing conditions, which resulted in an aerodynamic stall and subsequent impact with terrain. Contributing to the accident was the failure of the stall warning system to advise the crew of the approaching stall.

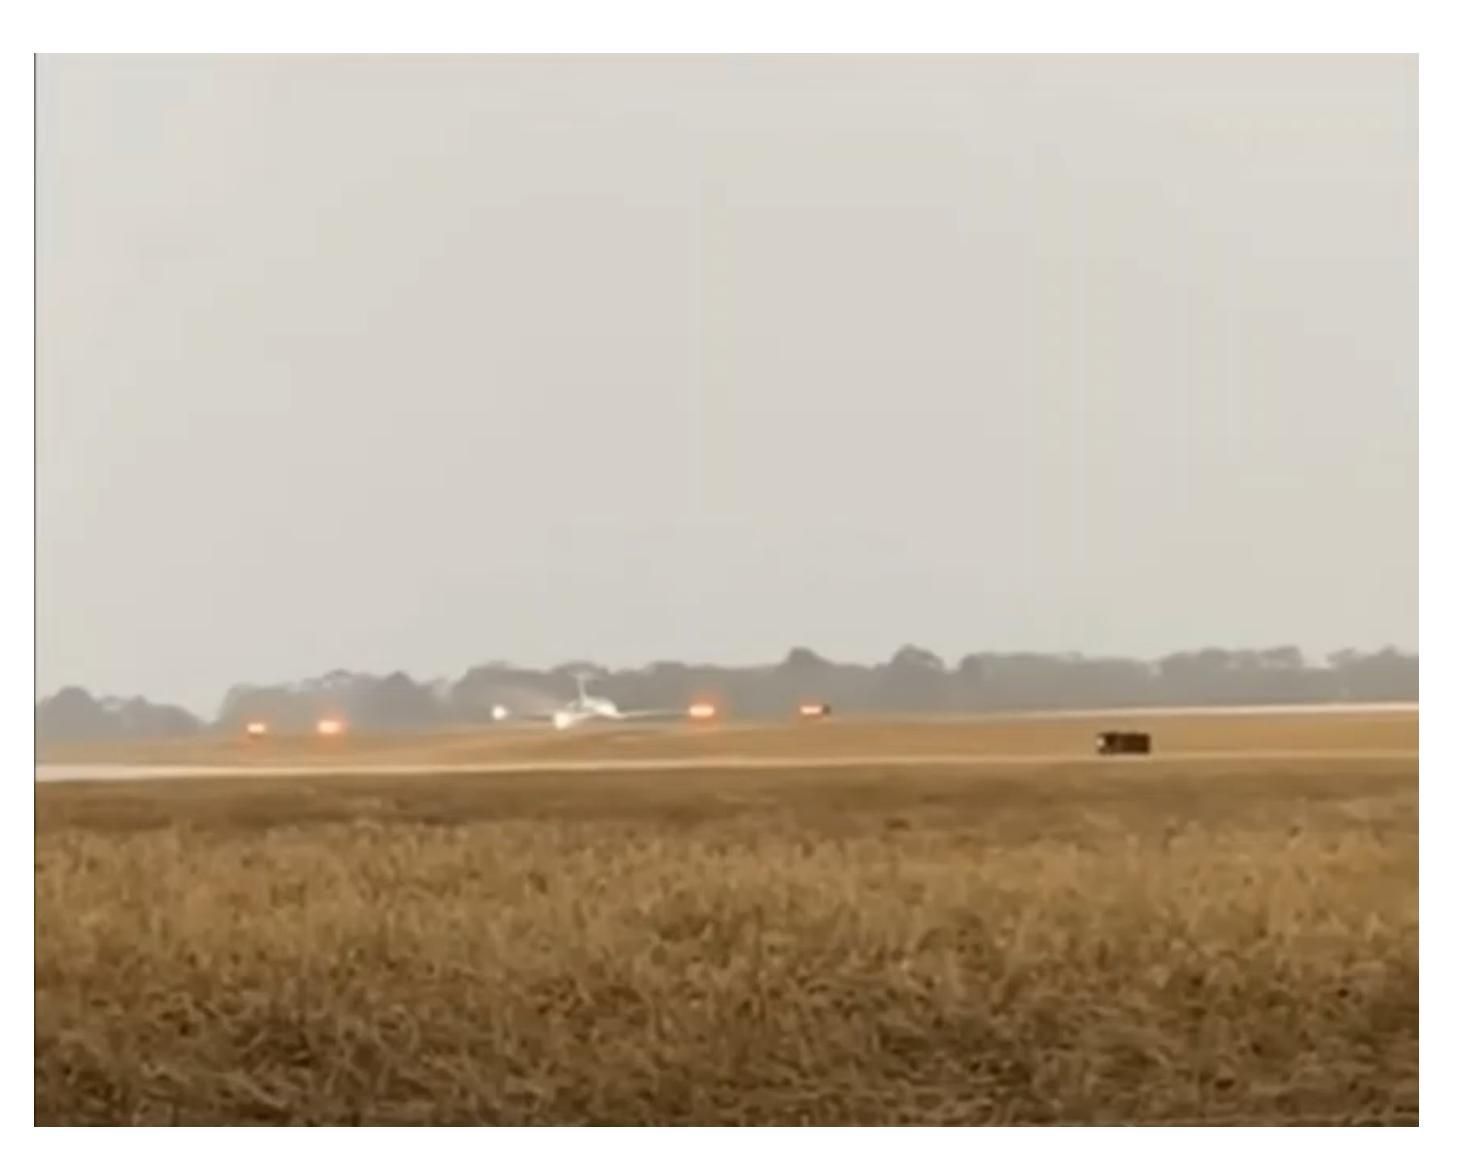
CEN21LA071 – Lufkin, TX Cessna C551, N48DK December 2, 2020 @ 0842 CST

- Part 91 IFR business flight
- Pilot >17,700 hr, 2,000 hr in type
- Austin (AUS) to Lufkin (LFK), TX
- RNAV approach RWY 16 (4,311 ft)
- Calculated stopping distance 4,127 ft
- Touched down 1,000 ft, on the wet runway and overran into grass.
- Anti-skid system stopped working on landing
