## **NTSB Weather Related Accidents**

Donald Eick – NTSB Senior Meteorologist Friends and Partners in Aviation Weather

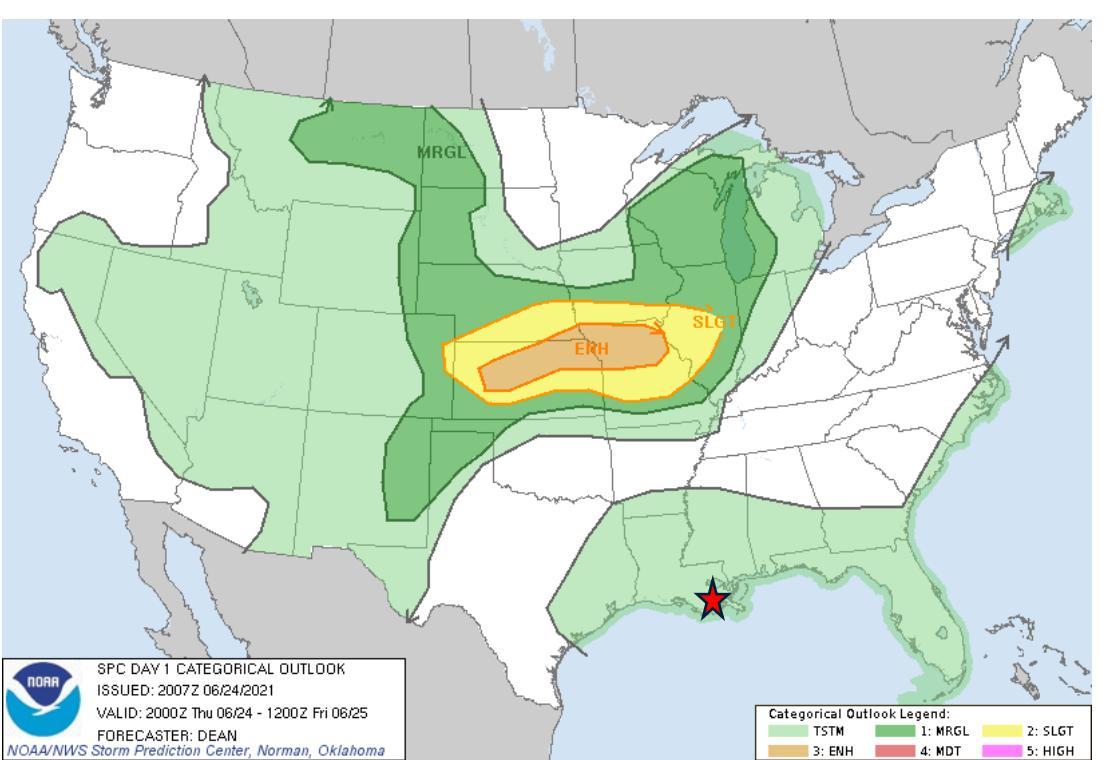
#### DCA21LA164 - New Orleans, LA

- Image: Image:
- A321 enroute @ FL310 in day VMC "smooth" conditions
- Seat belt sign-off, beverage service just completed
- Encountered sudden single jolt of severe turbulence; autopilot disconnect, aircraft rolled 30°, with 300 ft altitude deviation
- 1 FA thrown to ceiling fractured & 10 PAX not belted reported minor injuries
- PIC declared medical emergency & diverted to KMSY
- Convective SIGMET current for area TSTMS tops above FL450, moving 26020KT

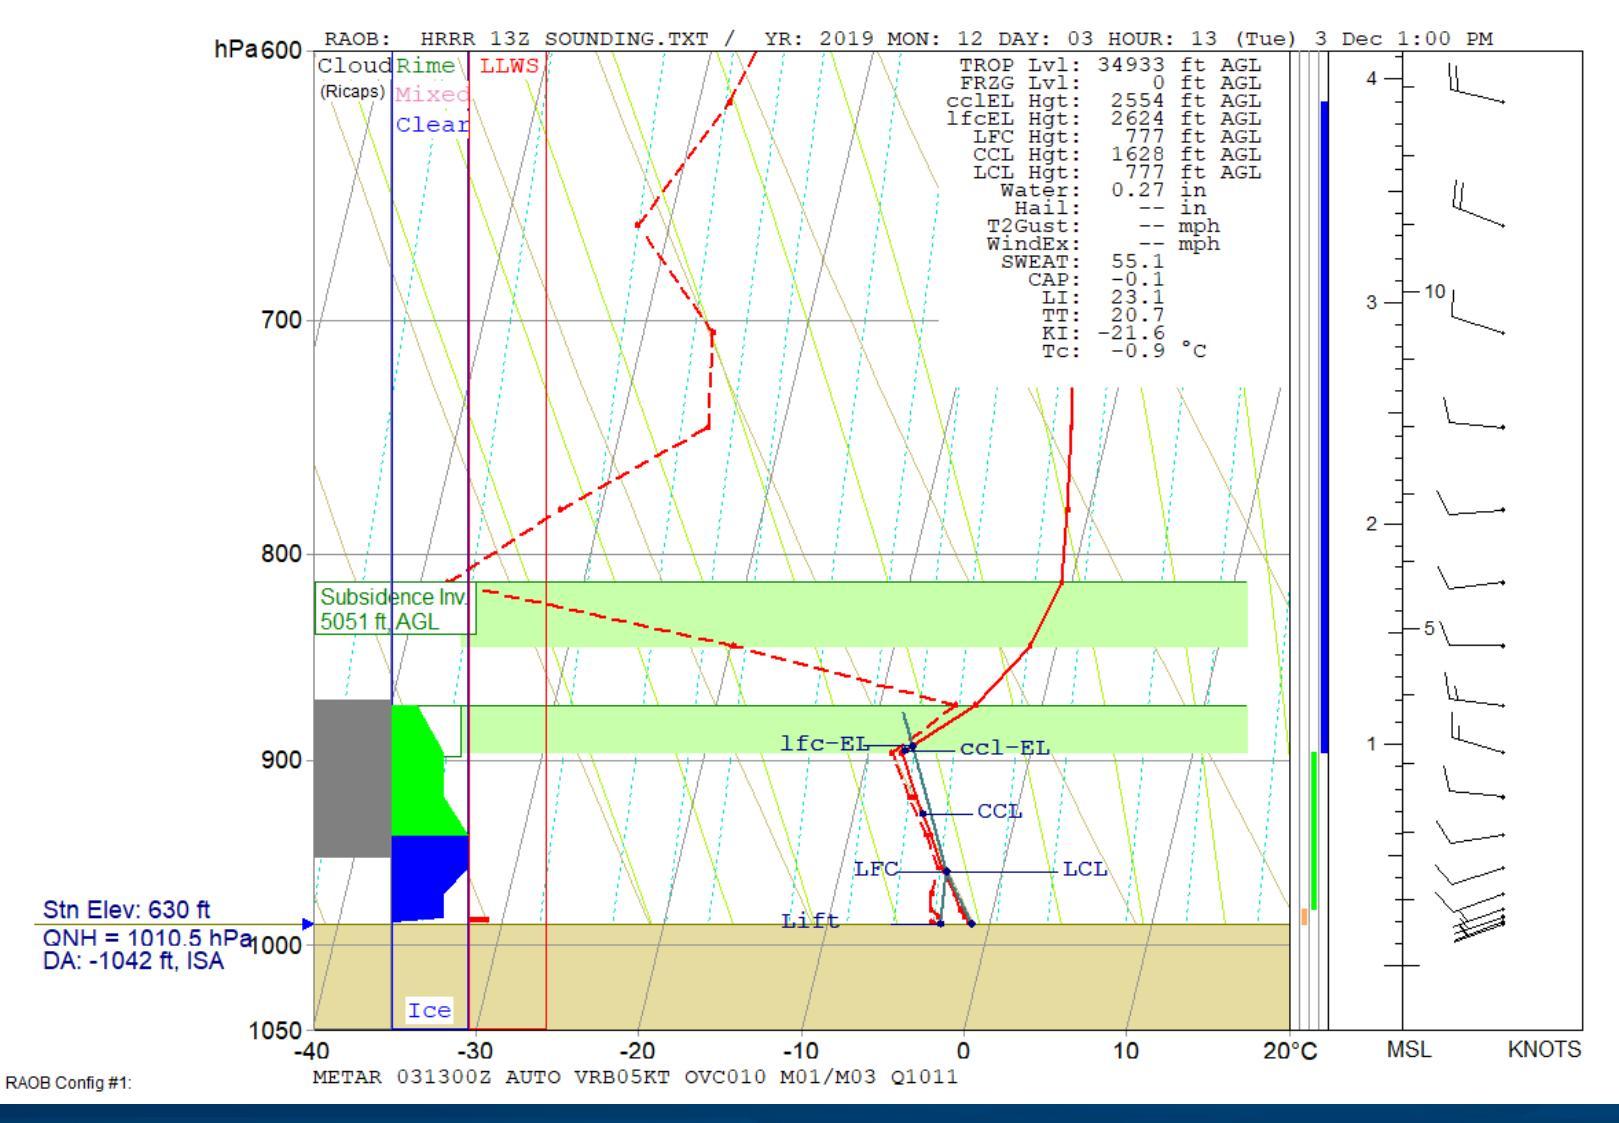
#### HRRR sounding for 1300Z

- Freezing level at surface
- LCL/LFC at 1,000 ft agl saturated thru 4,000 ft.
- Inversion from 3,000 ft thru 6,000 ft remaining below freezing.
- LGT-MOD mixed icing expected in clouds

AIRMET ZULU for OCNL MOD icing BLW 7,000 ft
