# **Friends and Partners in Aviation Weather (FPAW)**

Donald Eick

NTSB Senior Meteorologist

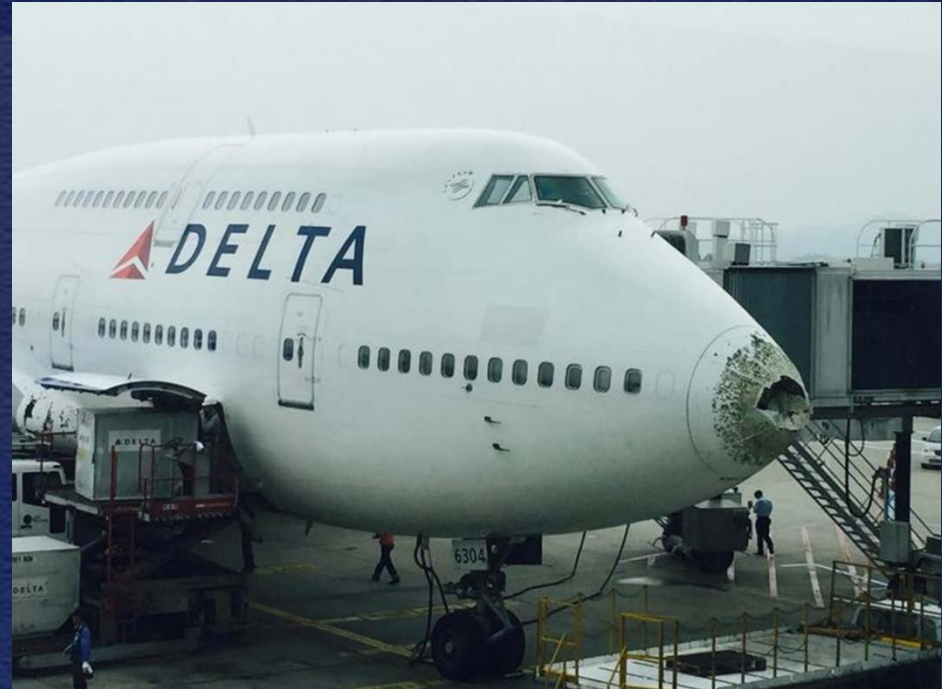
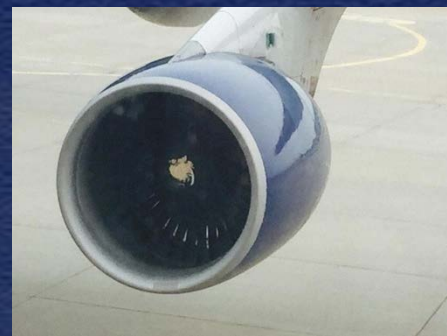
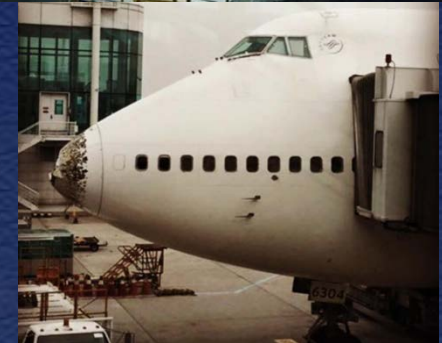
## Turbulence & Hail Encounter

- Delta F159 B747-400
- June 6, 2015
- Detroit – Seoul
- FL360 @ 0630Z
- Unable to get deviations around convection
- Encounters severe turbulence & hail
- Damage – radome, leading edges, engines
- Significant damage – aircraft retired from service
- Foreign Investigation

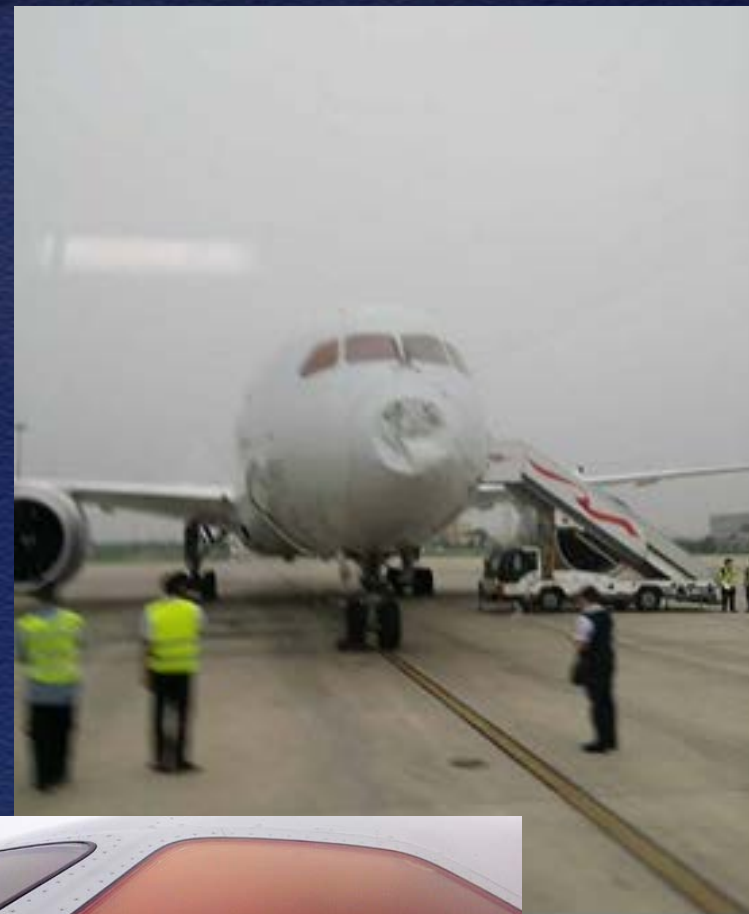
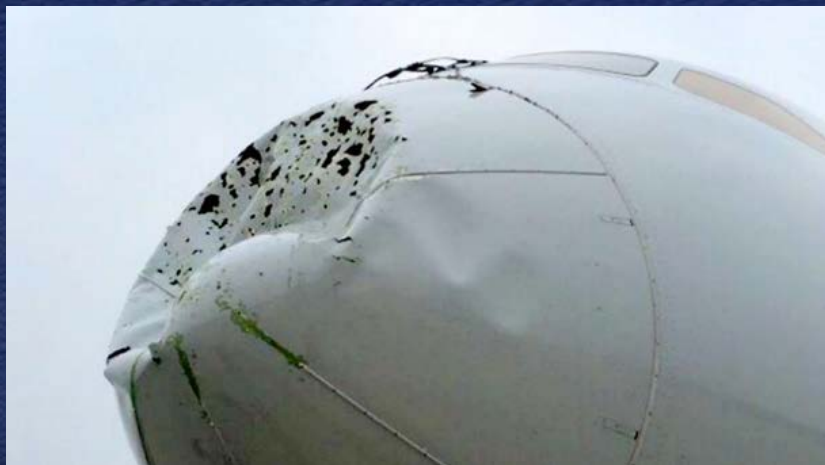
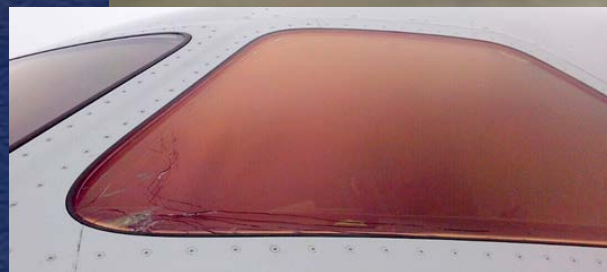
# Hail Encounter – International Event

- American Airlines B787
- July 27, 2015
- Hail encounter after departing Beijing
- Aircraft 3-months old, 4 weeks of maintenance to return to service
- Damage radome, side window, leading edge

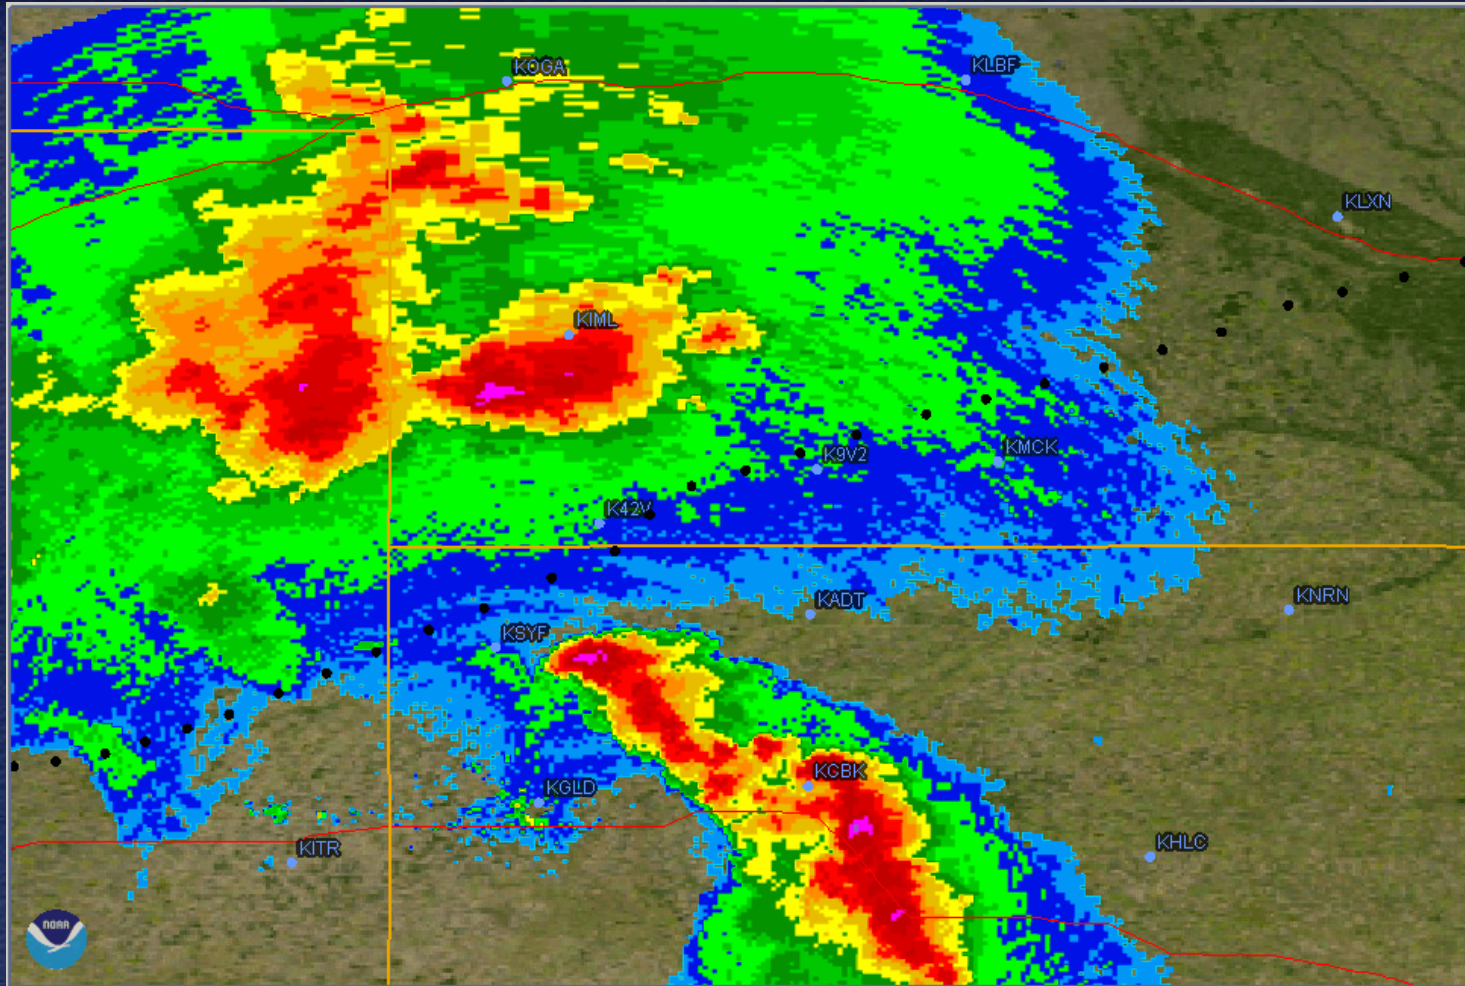
# Delta Hail Encounter

NEXRAD LEVEL-III  
COMPOSITE REF. 124NM  
KGLD - GOODLAND, KS  
08/08/2015 01:33:53 GMT  
LAT: 39/22/01 N  
LON: 101/42/00 W  
ELEV: 3717 FT  
MODE/VCP: A / 212

MAX: 71 dBZ  
BOT: 0 KFT  
TOP: 0 KFT

- Delta Airlines A320 flight #1889
- KBOS-KSLC
- Aug. 8, 2015 @ 0201Z
- Aircraft encountered SVR turbulence, hail, lightning at FL340
- Crew declared emergency & diverts to KDEN
- 3 minor injuries
- Southwest B737 also encountered SVR turbulence
- **On going investigation**

GLD UUA /OV GLD04447/TM 0214/FL340/TP A320/TB SEV/  
RM SEV HAIL- CRACKED WINDSHIELD ZDV

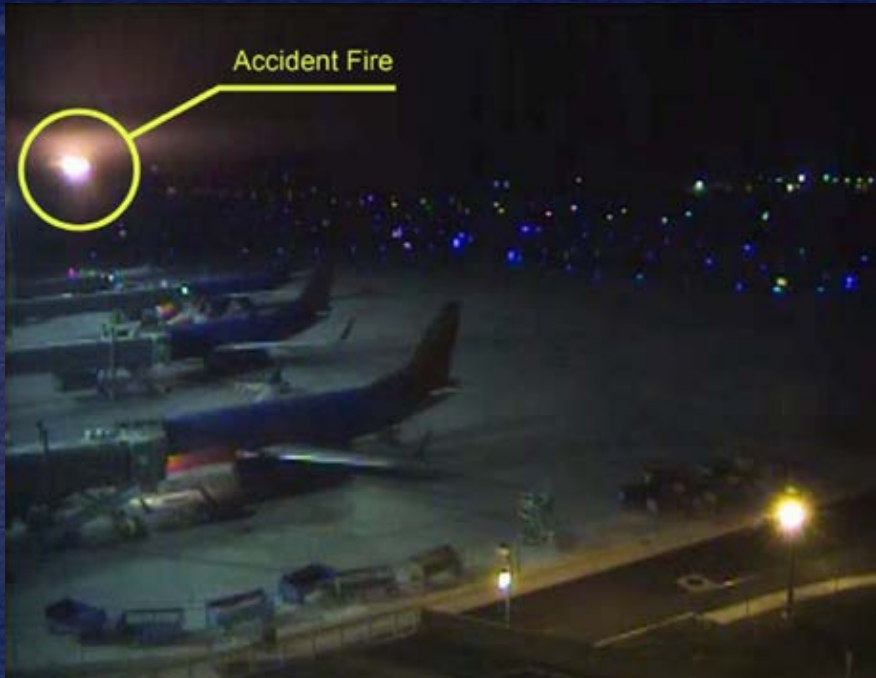
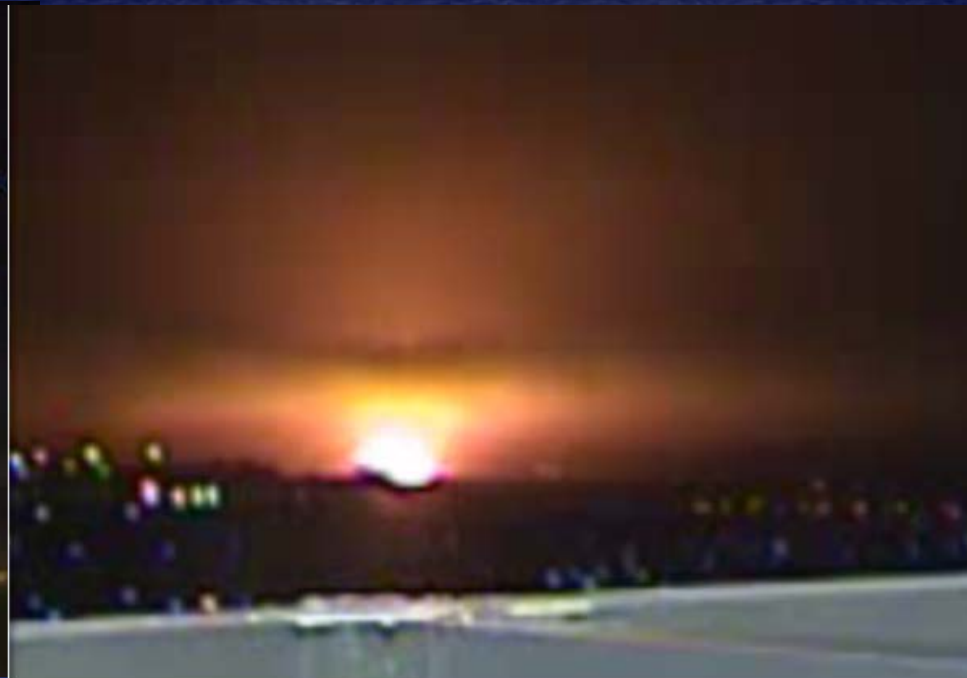
# UPS – Birmingham, AL

*METAR* KBHM 140753Z 0000KT 9SM OVC008 23/22 A2996

*RMK* AO2 CIG 007V011 SLP137 T02330217=

*SPECI* KBHM 140848Z 33003KT 10SM OVC010 23/22 A2997

*RMK* AO2 CIG 006V013=

*METAR* KBHM 140853Z 0000KT 10SM BKN010 OVC075 23/22 A2997

*RMK* AO2 CIG 006V013 SLP138 T02330217 52000=

*SPECI* KBHM 140904Z 0000KT 10SM SCT010 BKN075 23/22 A2996

*RMK* AO2=

*TAF AMD* KBHM 140647Z 1407/1506 VRB03KT P6SM BKN004

- Stationary front over the area producing LIFR to IFR conditions across the region – AIRMET issued
- UPS LIDO System – limitations; strips off METAR remarks, “SPECI” or “AMD”, unable to access UA, WA, CWA/MIS, AWW, other local obs
- NWS AWC site also noted stripping
- Lack of standardization s in ATC disseminate METAR remarks
- NOTAM – primary runway closed 0500 local

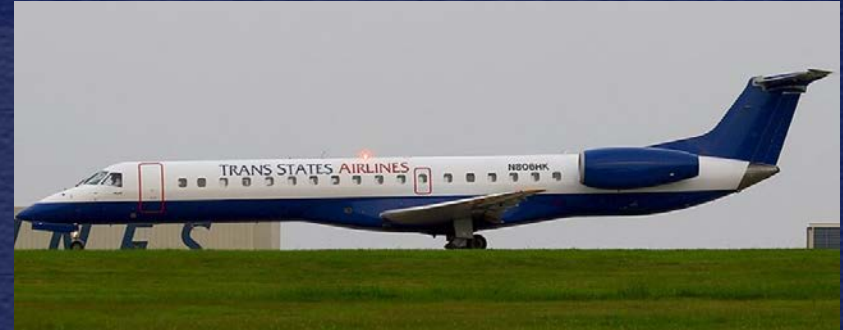
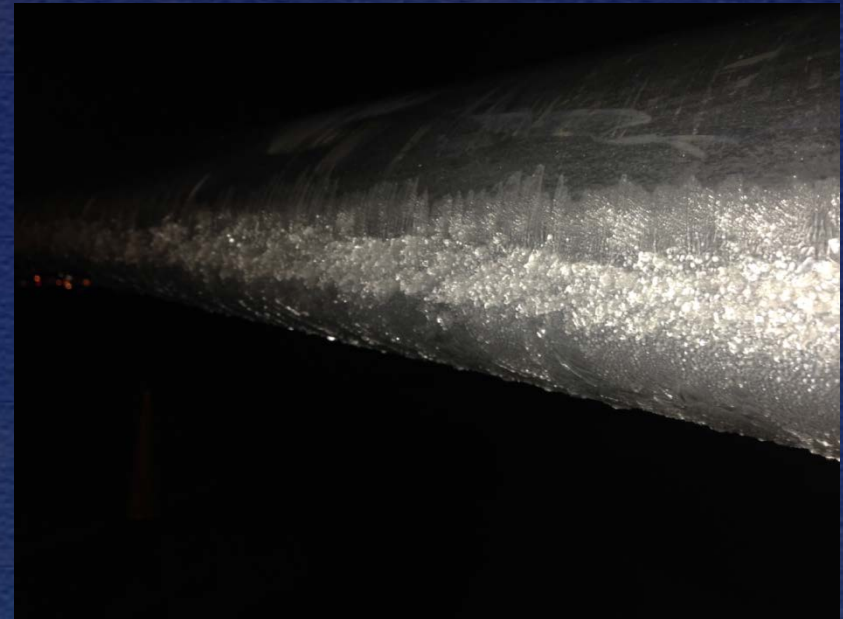
# DEN14FA058 – Memphis, TN

- Part 121 – IFR flight
- HOU-MEM
- Night IMC at MEM
- 1<sup>st</sup> approach missed, on 2<sup>nd</sup> approach 20-40 ft agl wing dropped & aircraft rolled right contacting runway
- On ramp all leading edges had significant mixed ice buildup

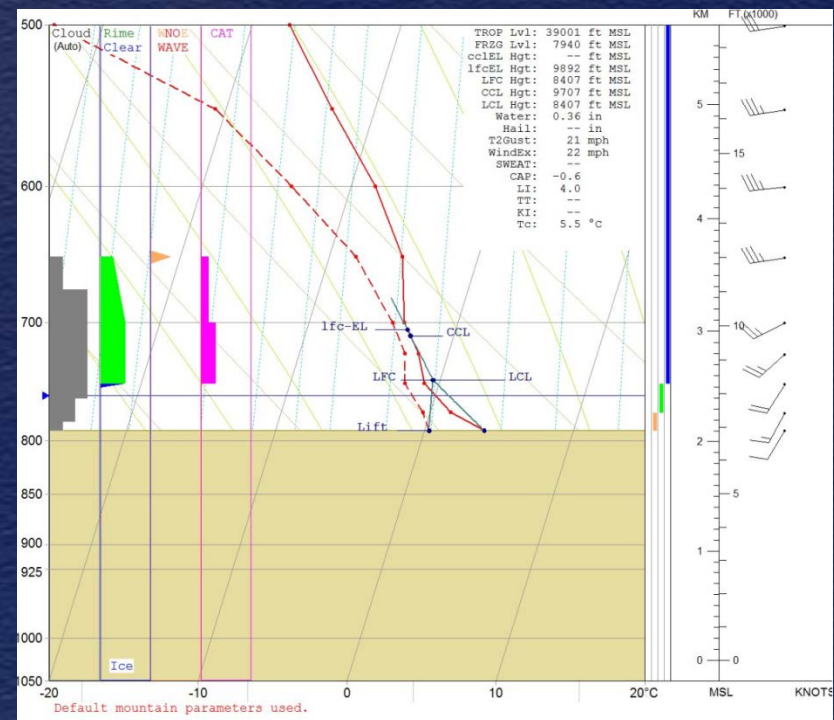
- METAR/TAF expected LIFR BR
- TAF tempo –FZDZ
- No AIRMET/SIGMET
- CWSU closed during period, no prior advisories
- CIP expected 50-70% of LGT icing below 3,000 ft

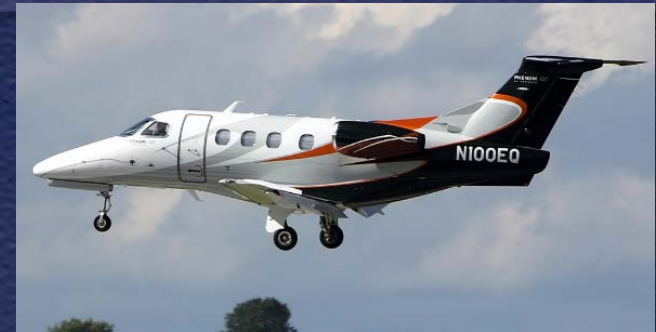
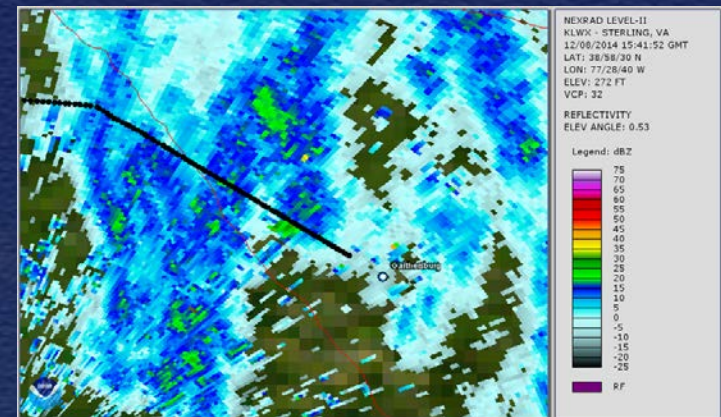
# DCA15MA027 – Gathersburg, MD

## Embraer EMB-500, N100EQ

### December 8, 2014

- Part 91 IFR business flight
- Chapel Hill, VA – Gaithersburg, MD
- Crashed on approach
- Fatal 3 aircraft, family 3 on ground
- Very light intensity echoes associated with snow squall
- Numerous reports LGT-MDT icing below 5,000 ft
- No advisories current for icing

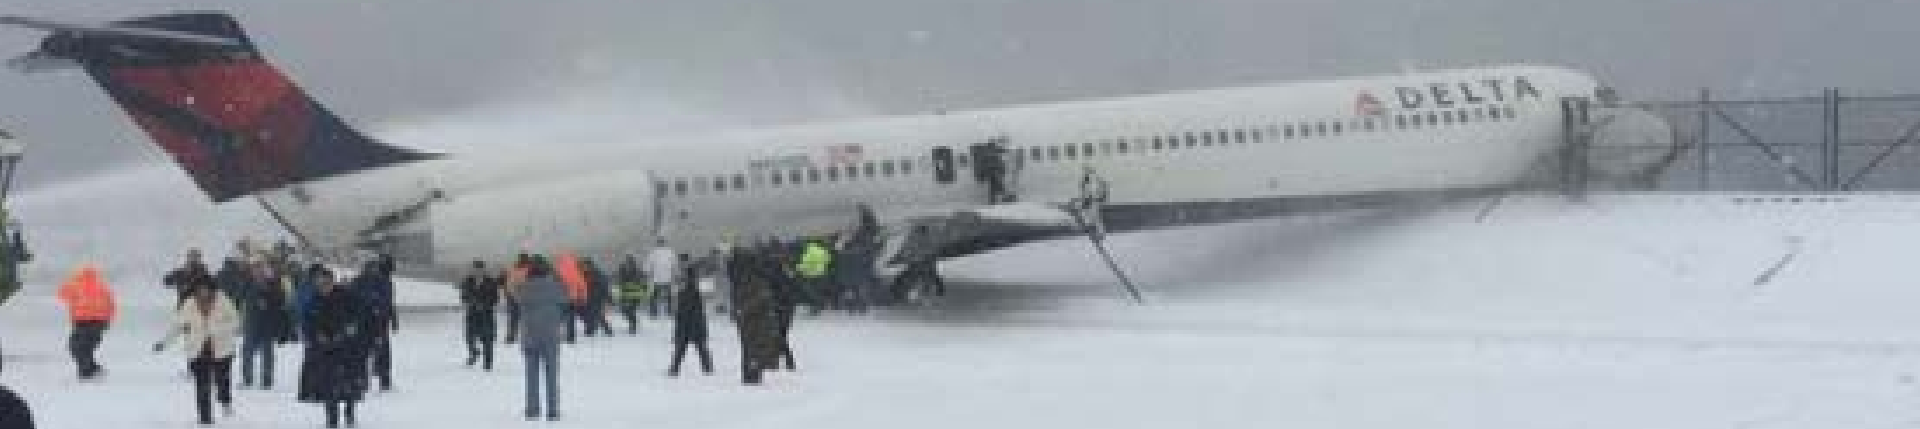
DCA15MA085 – LaGuardia Airport, NY  
Delta Airlines flight 1086, MD-83  
March 5, 2015

***KLGA 151600Z 02009KT 1/4SM R04/3000V4500FT SN FZFG VV009  
M03/M04 A3012 RMK AO2 P0001  
3 inches new snow at time of accident  
Landing runway 13 – quartering right crosswind/slight tailwind in  
moderate snow***
