The Ice Crystal Icing Hazard & Risk Mitigation: Delta Air Lines' Perspective

Bob Culver, Chief Line Check Pilot &
Tom Fahey, Mgr. Meteorology
Friends/Partners Aviation Weather (FPAW)
19 November 2015
Las Vegas, NV

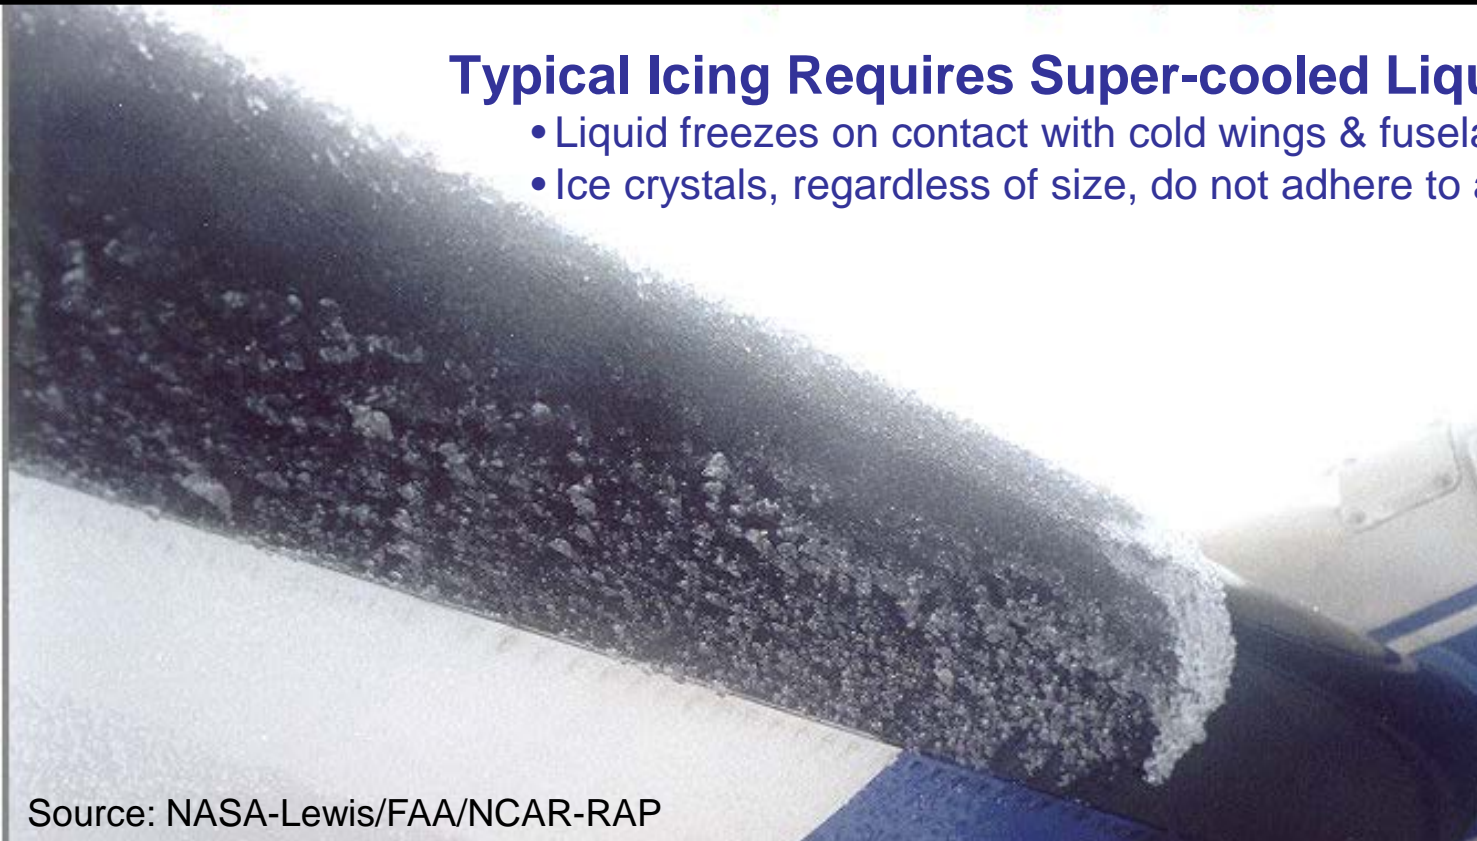
Typical Icing Requires Super-cooled Liquid Droplets

- Liquid freezes on contact with cold wings & fuselage surfaces.
- Ice crystals, regardless of size, do not adhere to a cold airframe
